MAPPING WATER QUALITY AT THE LAKE BUYUKCEKMECE, ISTANBUL BY USING IKONOS MULTISPECTRAL IMAGERY

The main purpose of this study is to present water quality conditions at the Lake Buyukcekmece, southwest Istanbul and investigate the feasibility of IKONOS multispectral imagery for water quality mapping in this fresh water reservoir for water quality parameters (WQPs) which are NO₃-N and suspended sediment (SS) concentration. Field work including water sampling and ground truth is simultaneously performed with the IKONOS satellite overpass of the March 2004. High resolution IKONOS multispectral imagery collected on March 25, 2004 is selected as remotely sensed data source for water quality mapping. Water quality models are developed by using multiple regression (MR) technique that is mostly used in many water quality studies. In the image processing step, radiometric correction procedure including conversion from DN (digital number) to spectral radiance is applied to already geometrically corrected IKONOS data. The results show that the measured and estimated values for WQPs are in good agreement with R² values of higher than 0.95. Additionally, the resulting water quality maps show sp

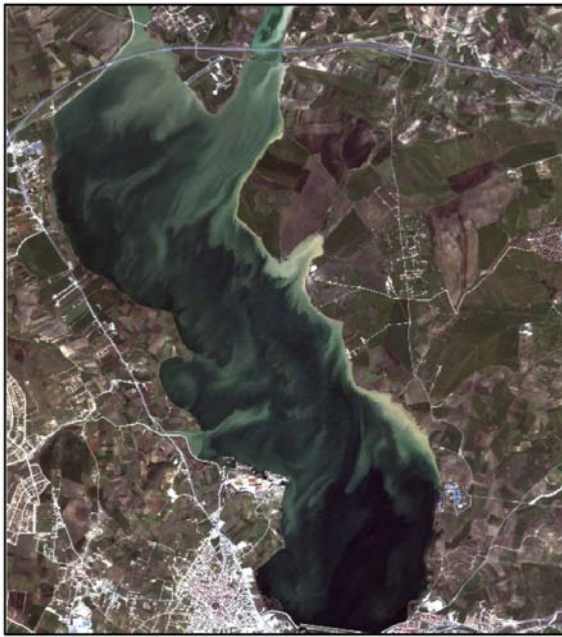
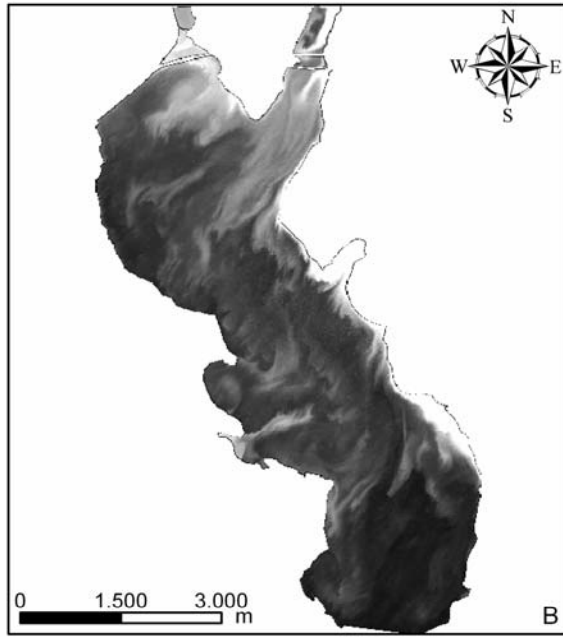
Figure 2. The details of multiple regression and water quality mapping processes for suspended sediment.

The results indicate that the accuracy of suspended sediment (SS) and nitrogen ($\text{NO}_3\text{-N}$) estimation by applying multiple regression algorithm is very high ($R^2=0.9948$ and 0.9234 respectively). Retrieved results for suspended sediment (SS) and nitrogen ($\text{NO}_3\text{-N}$) are presented in Figure 2 and Figure 3. The developed algorithms, which are derived by using multiple regression, were verified by using in-situ measurements collected at three individual sample points for validation of the developed model (Figure 4).

Water quality maps are produced by using the derived multiple regression models and in-situ measurements collected at the stations belonging to water quality parameters which are suspended sediment (SS) and nitrogen ($\text{NO}_3\text{-N}$). These maps present apparent spatial variations of selected parameters and inform the decision makers of water quality variations over the study area in the Lake Buyukcekmece, Istanbul.

The Lake Buyukcekmece receives wastewater directly from the municipal sewage treatment and agricultural sources. These discharges have load nutrients to the lake. The interpretations of resultant water quality maps verify this circumstance. Especially, (relatively) high suspended sediment (SS) and nitrogen ($\text{NO}_3\text{-N}$) concentrations along the east coast of the lake indicate the discharges coming from the agricultural areas located along the east coasts of the Lake Buyukcekmece.

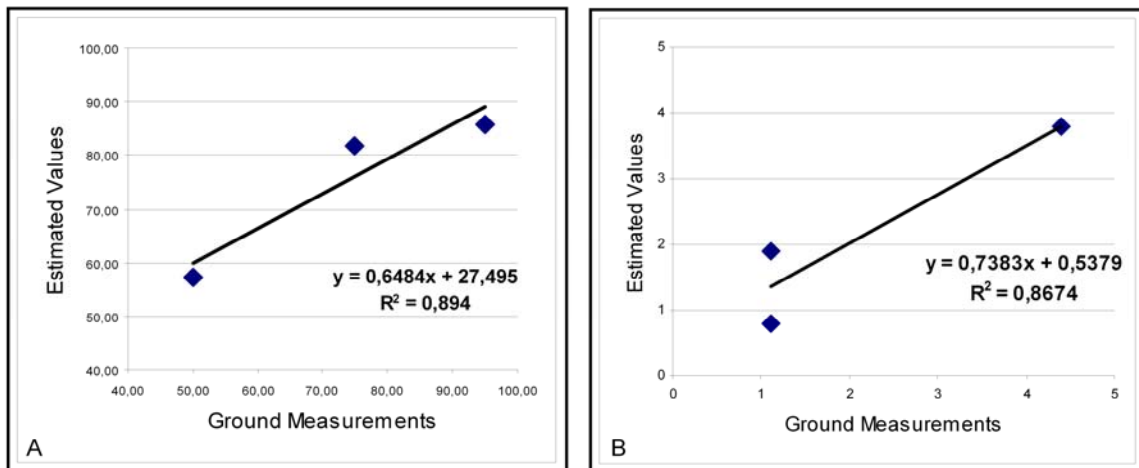
Figure 4. Verification of the developed algorithms (a) Suspended sediment (b) NO_3-N .
